Corrosion & Metallurgical Testing Laboratories

TEST REPORT

SALT SPRAY (FOG) TEST ASTM B-117

Geopolymer Solutions, LLC 11200 Cox Road Conroe, Texas 77385 Attn: Mr. Rod Zubkod December 4, 2018 **Report No.: C18-334.2**

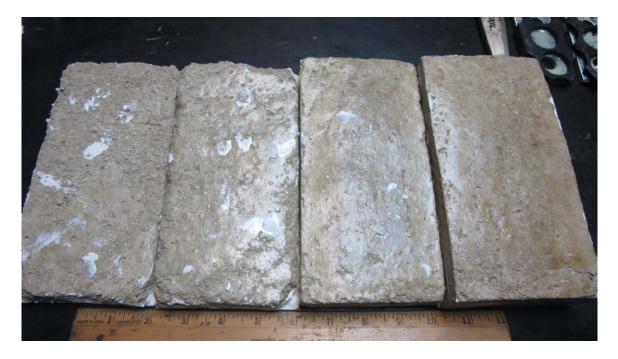
Insulated metal panels before exposure

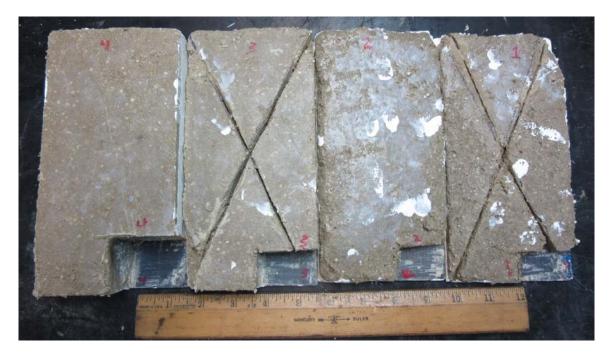
Insulated metal panels after 250 hours of exposure

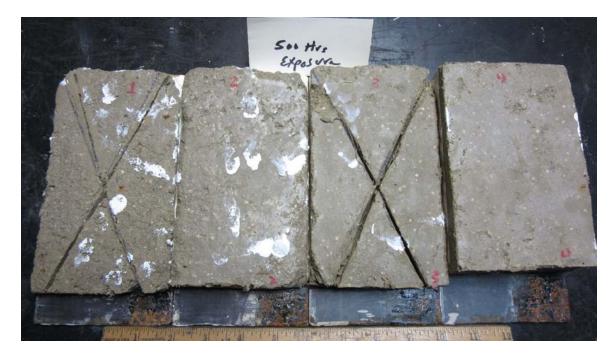
Insulated metal panels after 500 hours of exposure

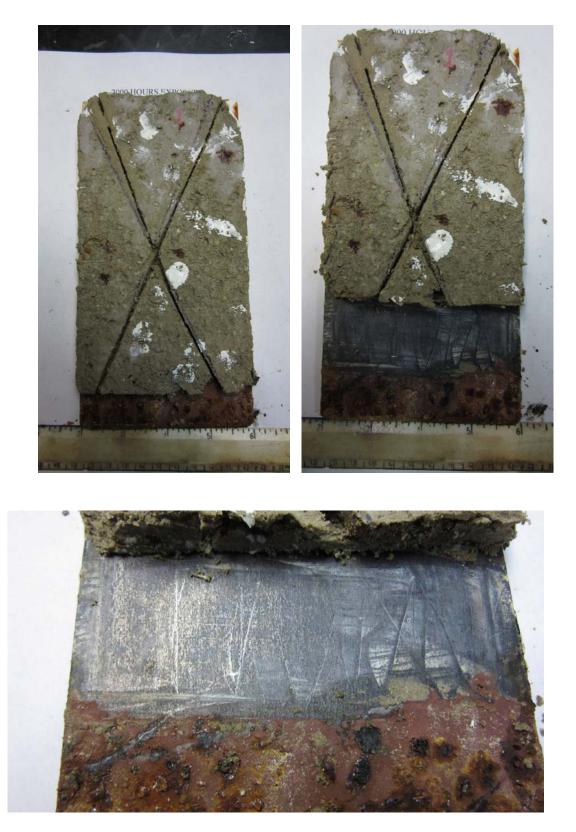
After completion of 2000 hours of salt spray exposure test, all four insulated steel panels were evaluated for presence of spot rusting, and corrosion attack to the metal substrate protected by insulation. A small area of insulation from each sample was removed to inspect the condition of the metal substrate. Visual examination revealed that the metal substrate under the insulation was virtually free from any spot rusting or corrosion damage due to salt spray exposure testing. Furthermore, it appears that the protection of the metal substrate under the insulation is independent of insulation thickness.

Insulated metal panels after 2000 hours of exposure

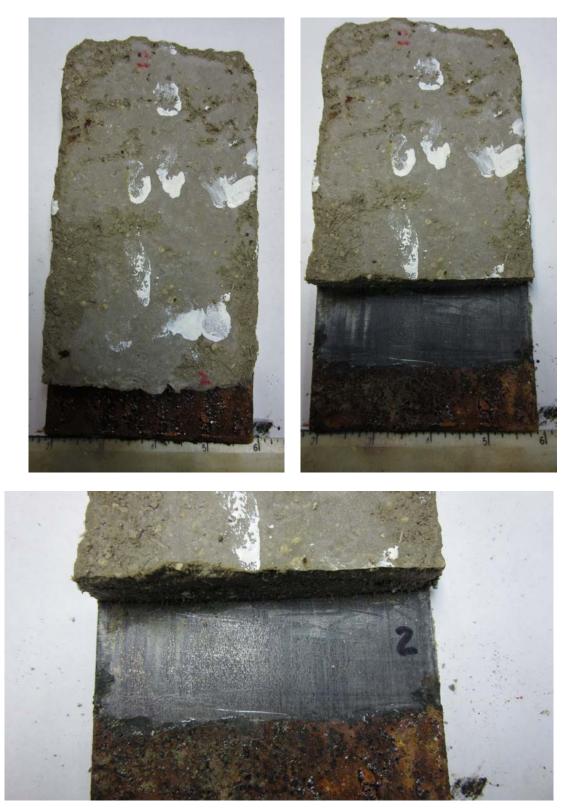
Insulated metal panels after 2000 hours of exposure

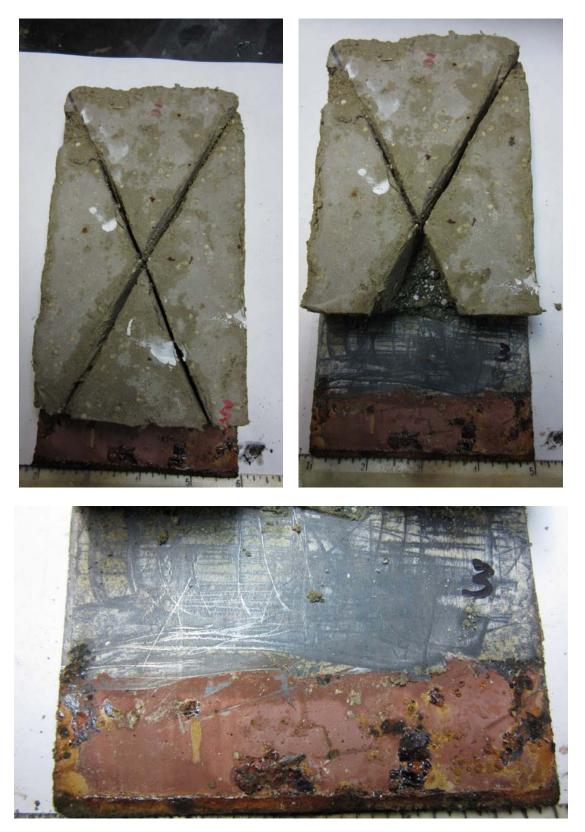
Insulated metal panels after 2000 hours of exposure

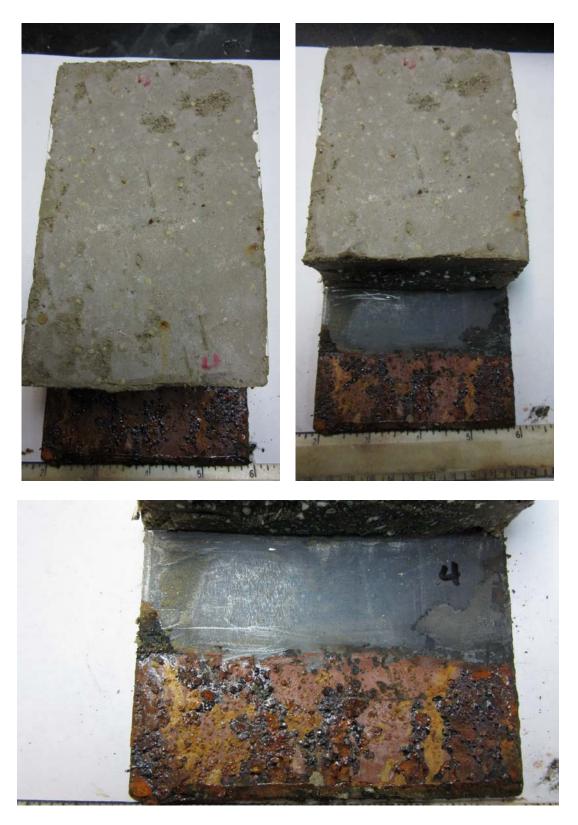
Insulated metal panels after 2000 hours of exposure
